Manhole Inspection Summary

Manhole # S09A1_021MH

Insp Date: **5/14/08 2:03 PM**

Location Address: **3501 Benson Av**

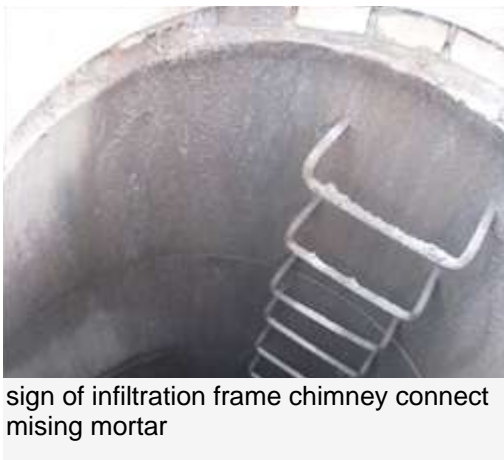
Defect 2

sign of infiltration frame chimney connect
missing mortar

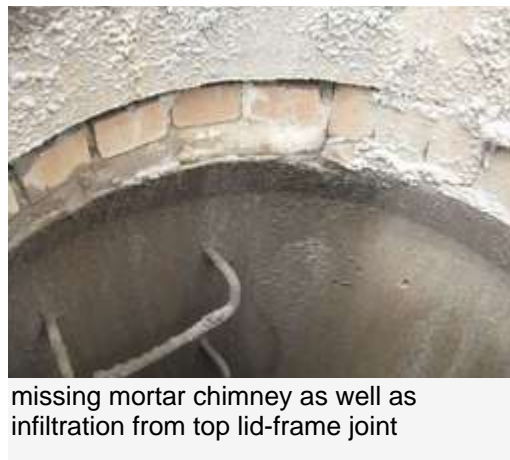
Defect 1

Frame Offset: **0** (in.) Condition: ☐ Sound ☐ Cracked ☒ **Leaks**

Chimney / Frame Adjustment ☒ Exists Material: **Brick** ☐ Parged Height: **5** (in.)
Condition: ☐ Sound ☐ Cracked ☐ Root Intrusion ☒ **Loose Brick** ☐ Deteriorated
Infiltration: ☐ None ☒ **Joint** ☐ Cracks ☒ **Mortar** ☐ Roots ☐ Wall

missing mortar chimney as well as
infiltration from top lid-frame joint

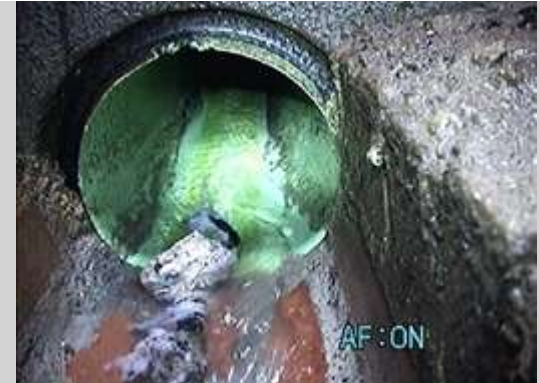
12 O'Clock Outflow

Pipe Height: **8.4** (in.) Rod and Bar (Angled)
Pipe Material: **PVC** ☐ Pipe Lined
Invert Depth: **17.69** (ft.) Flow Characteristics: **Fast**
Deposits: ☒ None ☐ Mud ☐ Sludge ☐ Debris ☐ Grease
Silt Depth: **0** (in.) Deposits Extent:
Infiltration: **None** Pipe Seal Cond: **Sound**

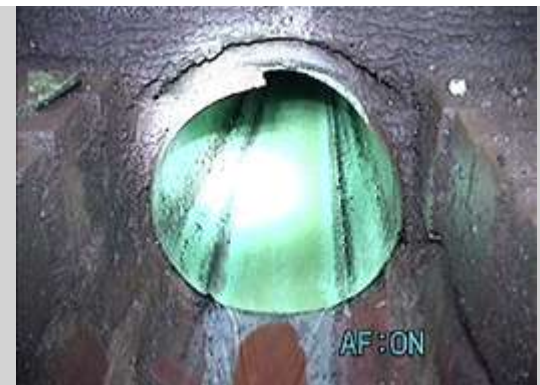
6 O'Clock Inflow

Pipe Height: **8.4** (in.) Rod and Bar (Angled)
Pipe Material: **PVC** ☐ Pipe Lined
Invert Depth: **17.48** (ft.) Flow Characteristics: **Fast**
Deposits: ☒ None ☐ Mud ☐ Sludge ☐ Debris ☐ Grease
Silt Depth: **0** (in.) Deposits Extent:
Infiltration: **None** Pipe Seal Cond: **Sound**
